Debris/Ice/TPS Assessment and Integrated Photographic Analysis of Shuttle Mission STS-82

Technical Memorandum 112647

April 1997

11 February 1997

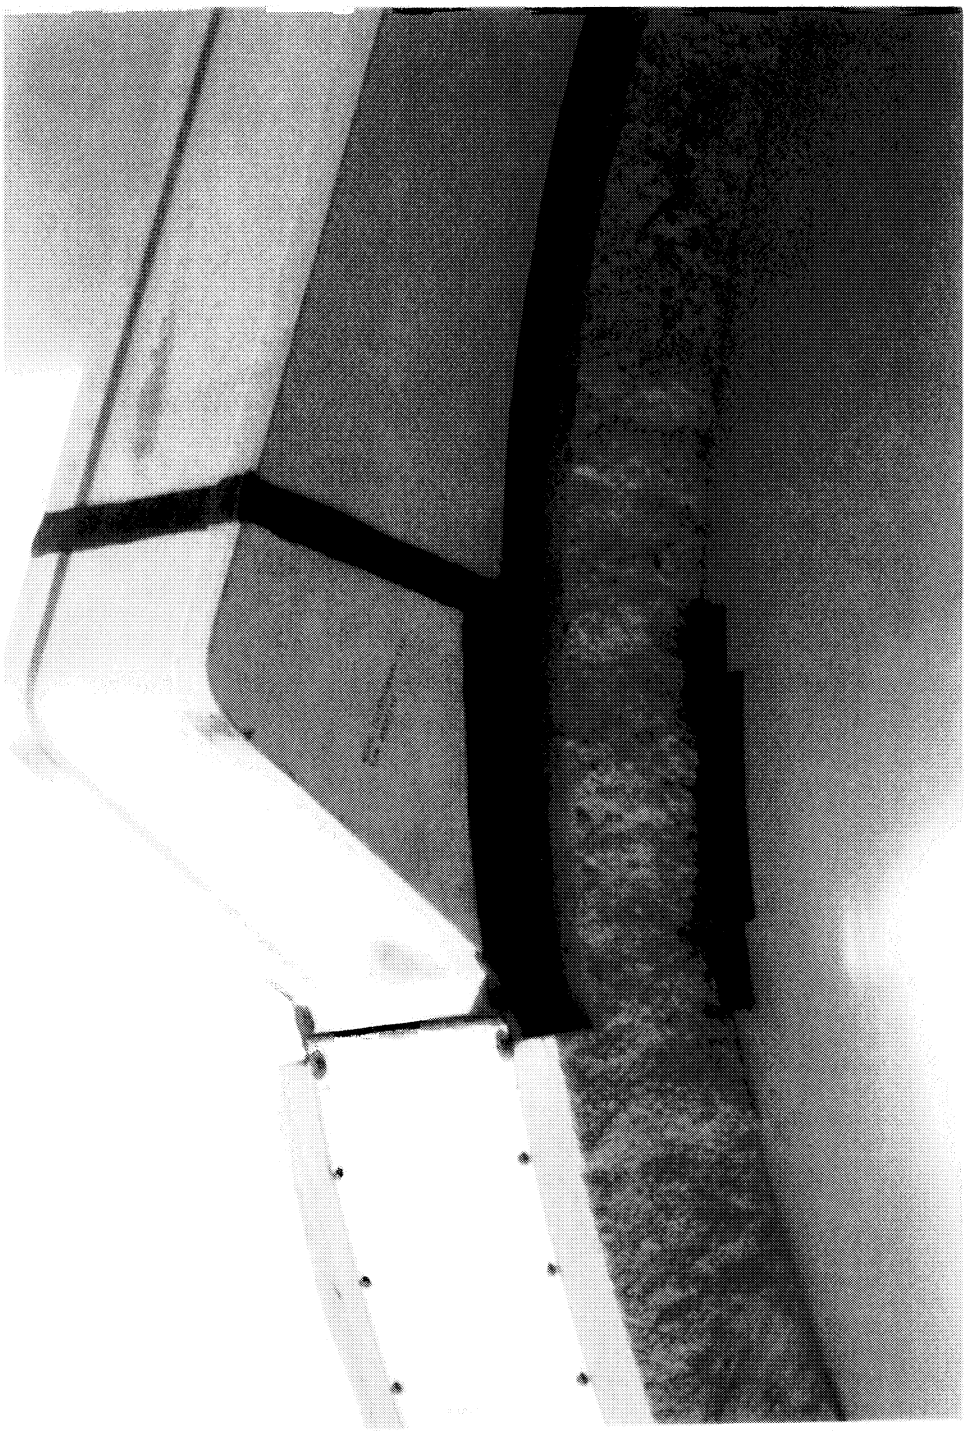
Photo 2: Tape Inadvertently Left on LH SRB Aft Booster

Tape was inadvertently left on the LH SRB aft booster just aft of the IEA. The tape, used during IEA closeout/ablator trimming, was detected during the Pre-Launch Inspection, but after the Orbiter Weather Protection (OWP) platforms had been retracted. MRB approval (IPR 82V-0262) to fly the tape rather than re-extending the OWP's was obtained.

Tape inadvertently left on the LH SRB aft booster just aft of the IEA adhered to the SRM case through tower clear (E-31 and E-40). The tape, used during IEA closeout/ablator trimming, had been detected during the Pre-Flight Inspection, but after the Orbiter Weather Protection (OWP) platforms had been retracted. MRB approval (IPR 82V-0262) to fly the tape rather than re-extending the OWP's was obtained.

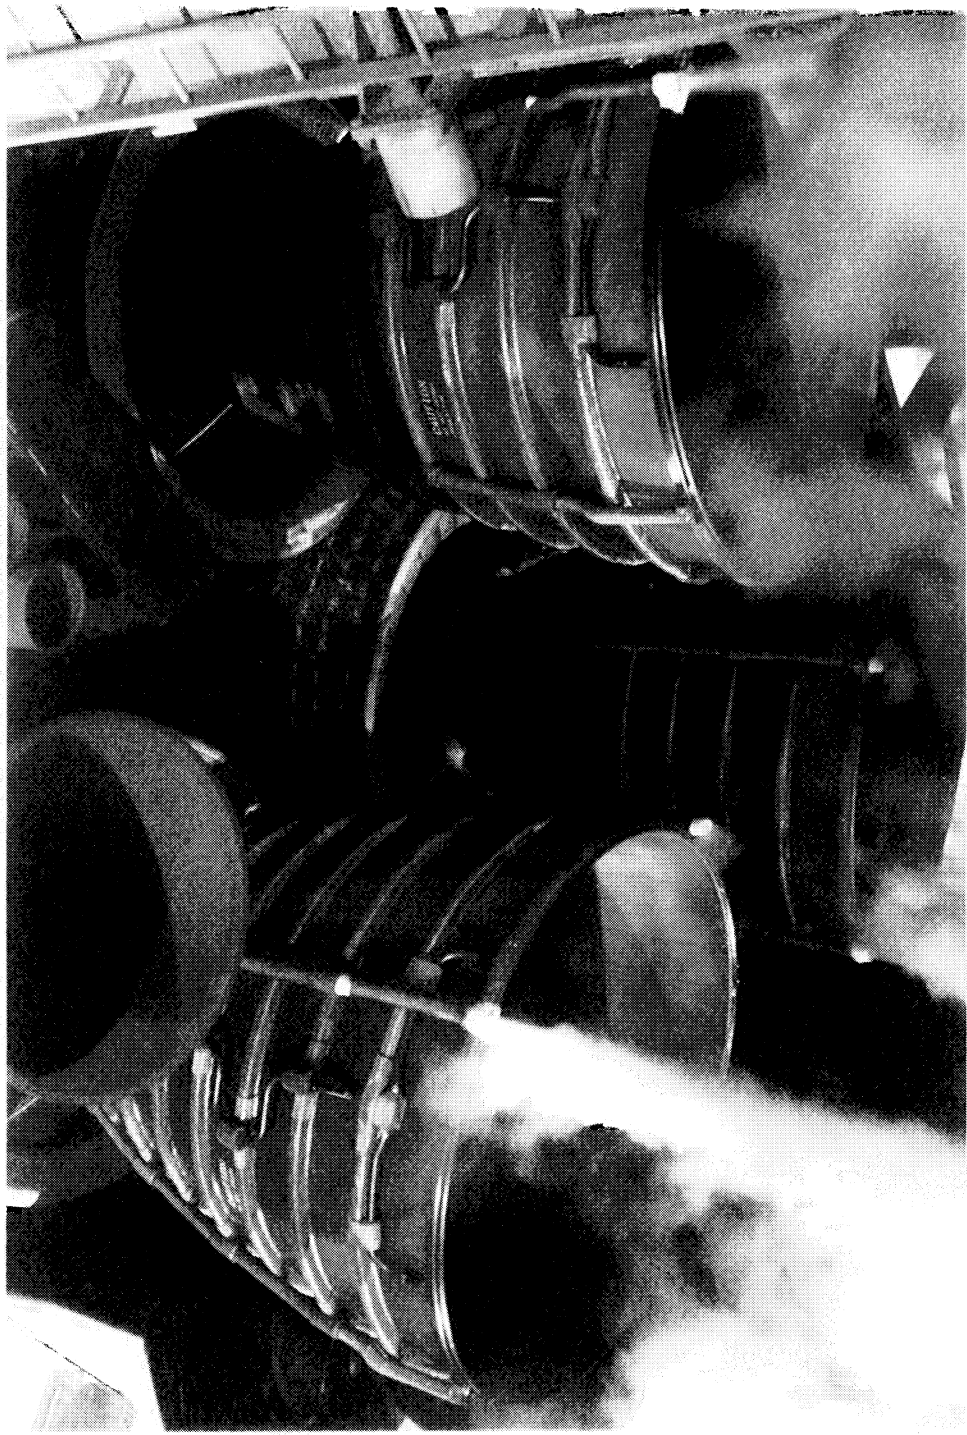
Photo 4: Ice/Frost and Condensate on SSME #2 Heat Shield-to-Nozzle Interface

No Orbiter tile or RCC panel anomalies were observed. The F2U, R2U, R3D, and R4D RCS thruster covers were intact, but tinted green indicating small internal vapor leaks. Ice/frost and condensate had formed on SSME #1 and #2 heat shield-to-nozzle interfaces. Condensate was present on the SSME #3 heat shield-to-nozzle interface. An infrared scan revealed no unusual temperature gradients on the base heat shield or engine mounted heat shields.

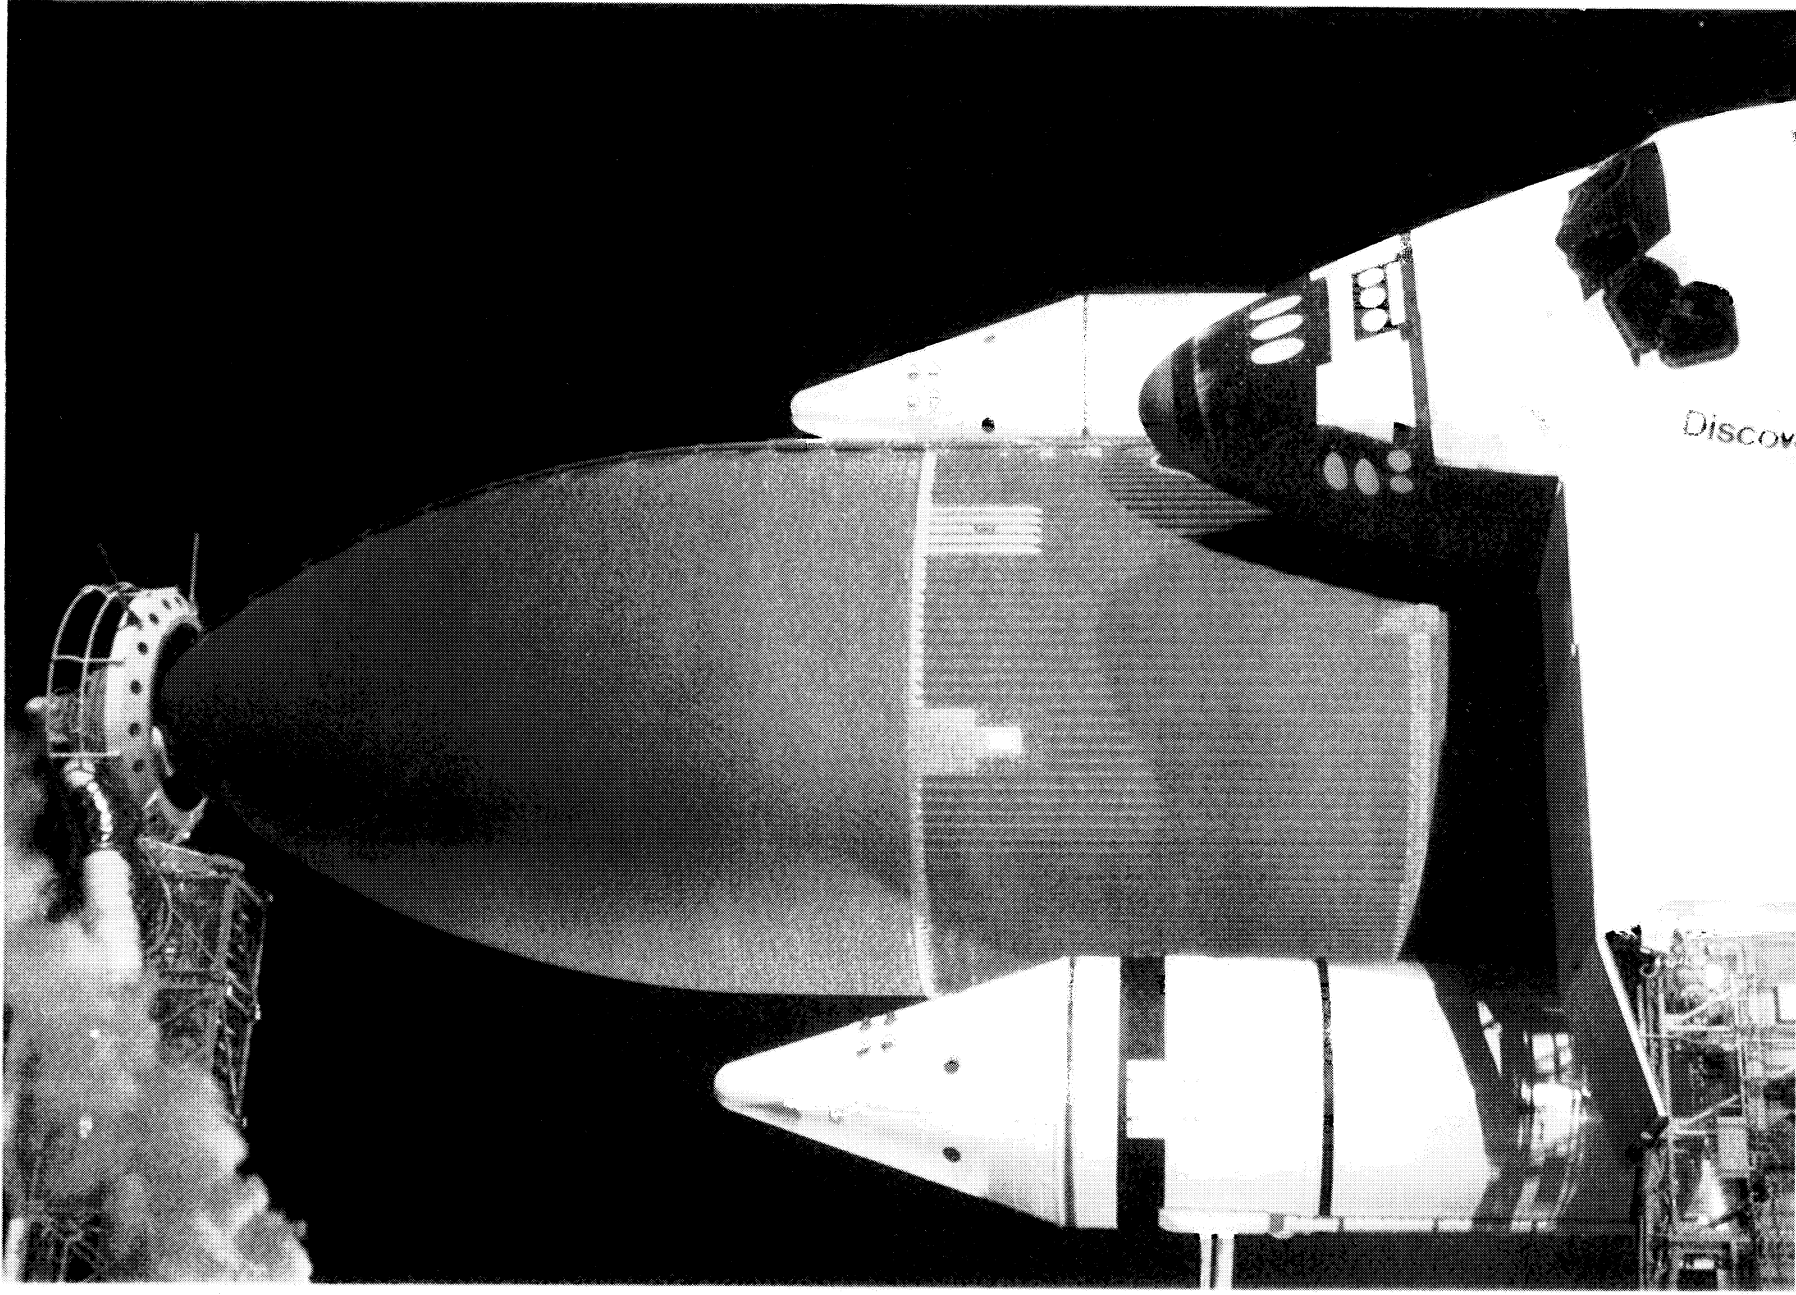
Photo 5: LO2 Tank and Intertank

The Final Inspection Team observed very light condensate, but no ice or frost accumulations, on the LO2 tank. TPS surface temperatures ranged from 42-48 degrees F.

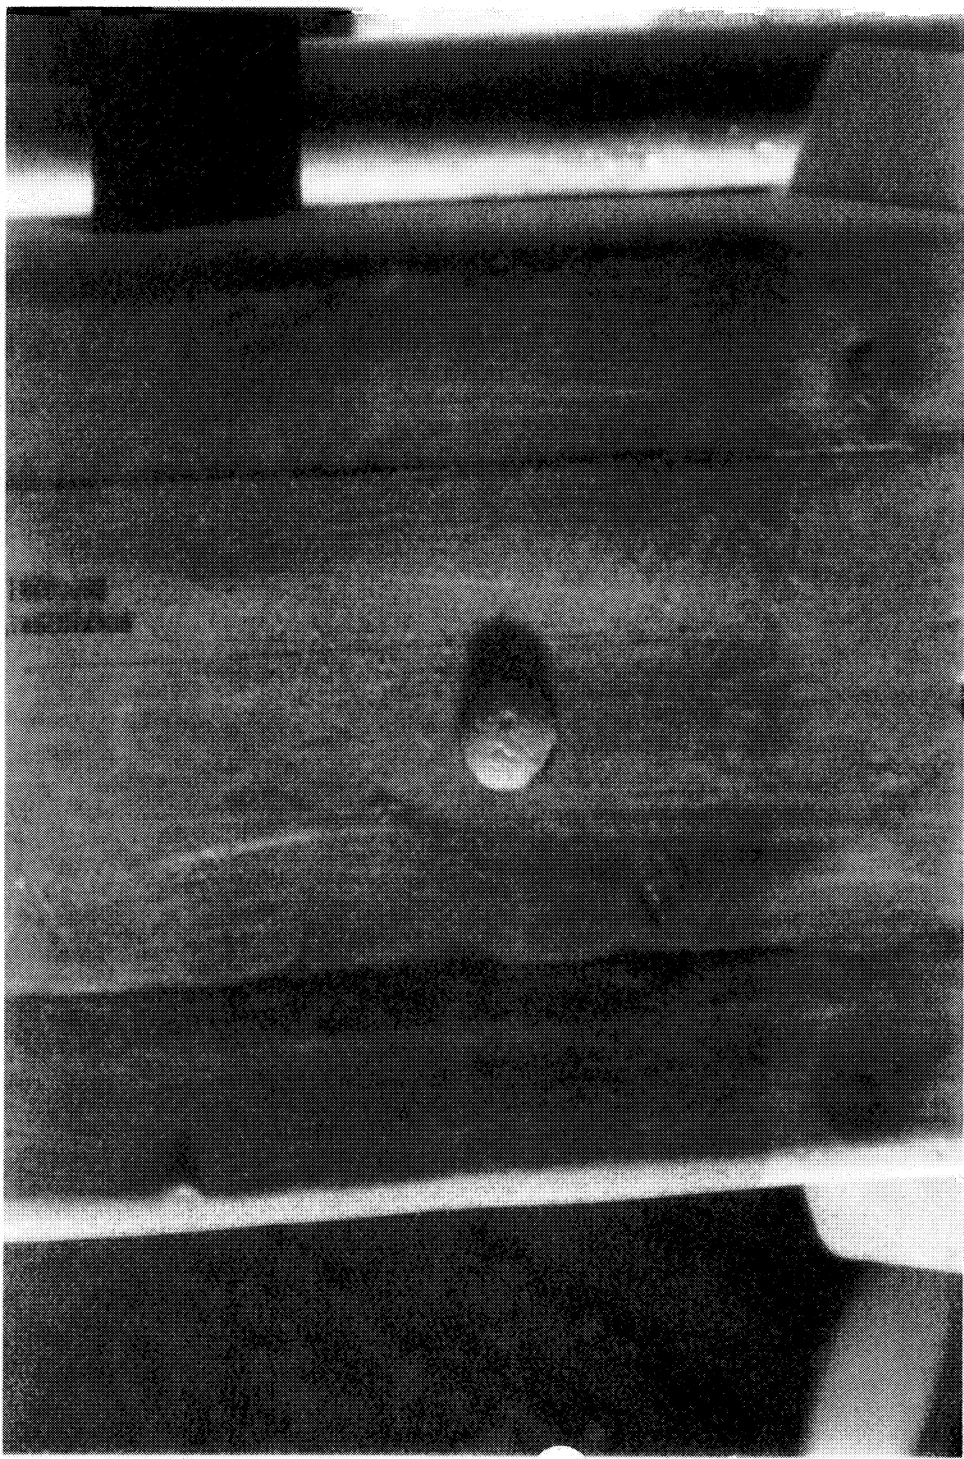
Photo 6: Protruding PDL Repair

There were no TPS anomalies on the LO2 ET/ORB umbilical. Ice/frost fingers on the separation bolt pyrotechnic canister purge vents were typical. A 1-1/2 inch diameter PDL repair on the aft surface of the umbilical cable tray was not flush (protruded slightly) with the surrounding TPS.

A 1-1/2 inch diameter PDL repair on the aft surface of the umbilical cable tray was not flush (protruded slightly) with the surrounding TPS.

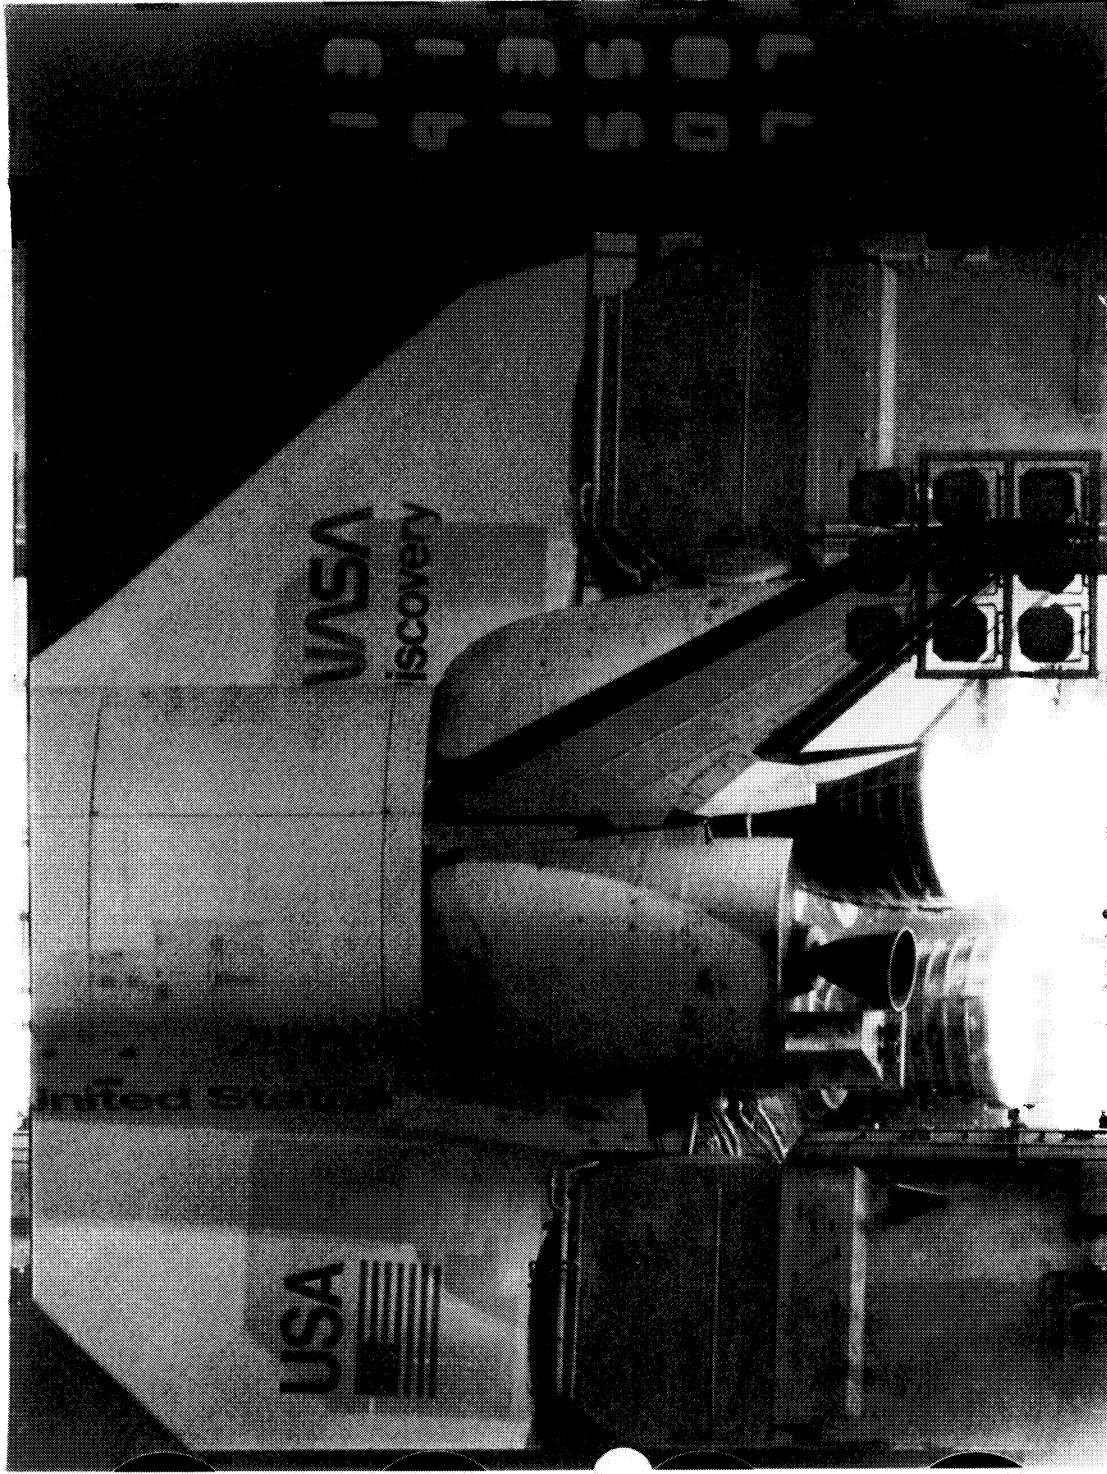
With the exception of Mach diamond formation (in the order 2-3-1), SSME ignition appeared normal (OTV-051, -070, -071). Free burning hydrogen drifted up to the OMS pods (OTV-070 and -071; E-16, -19).

Photo 7: SSME Mach Diamond Formation
SSME #2 Mach Diamond formed prior to SSME #3.

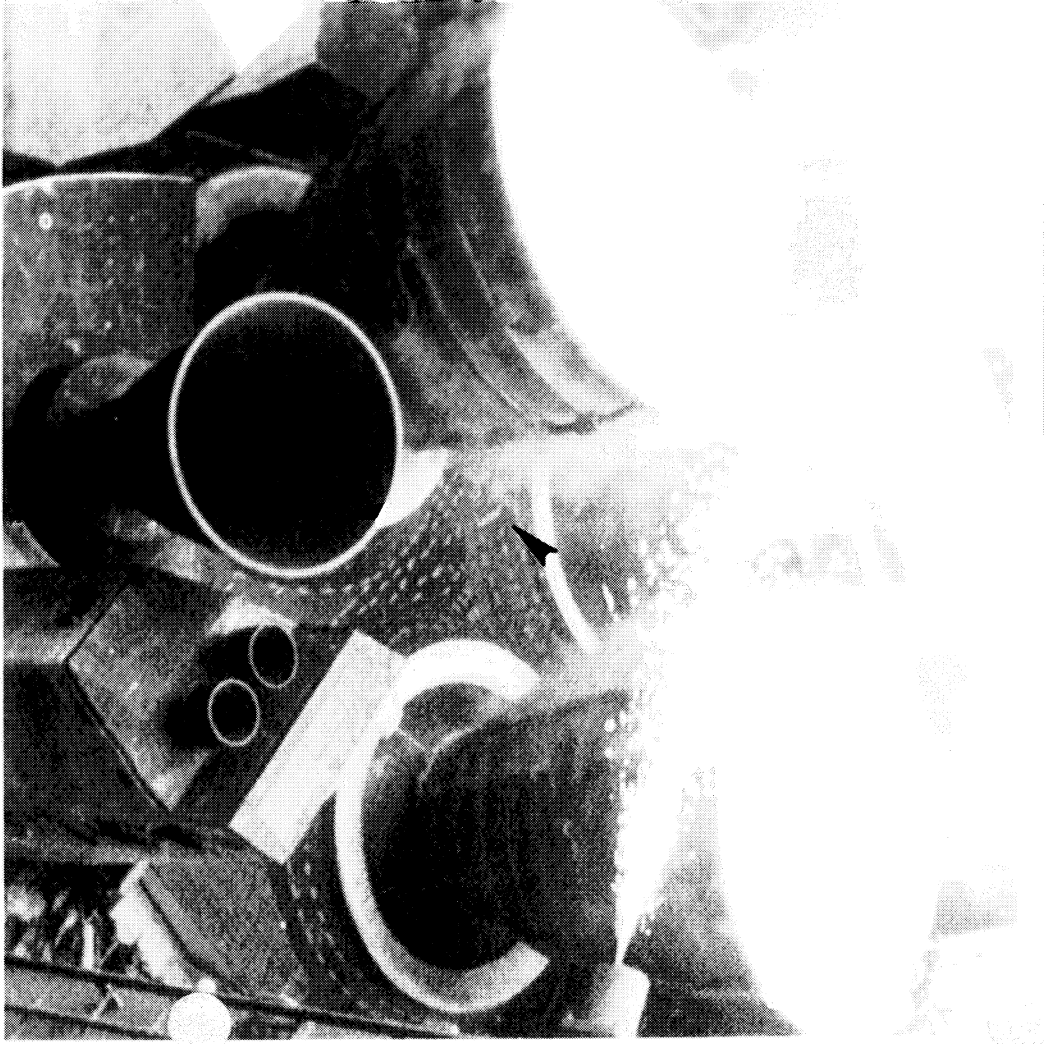
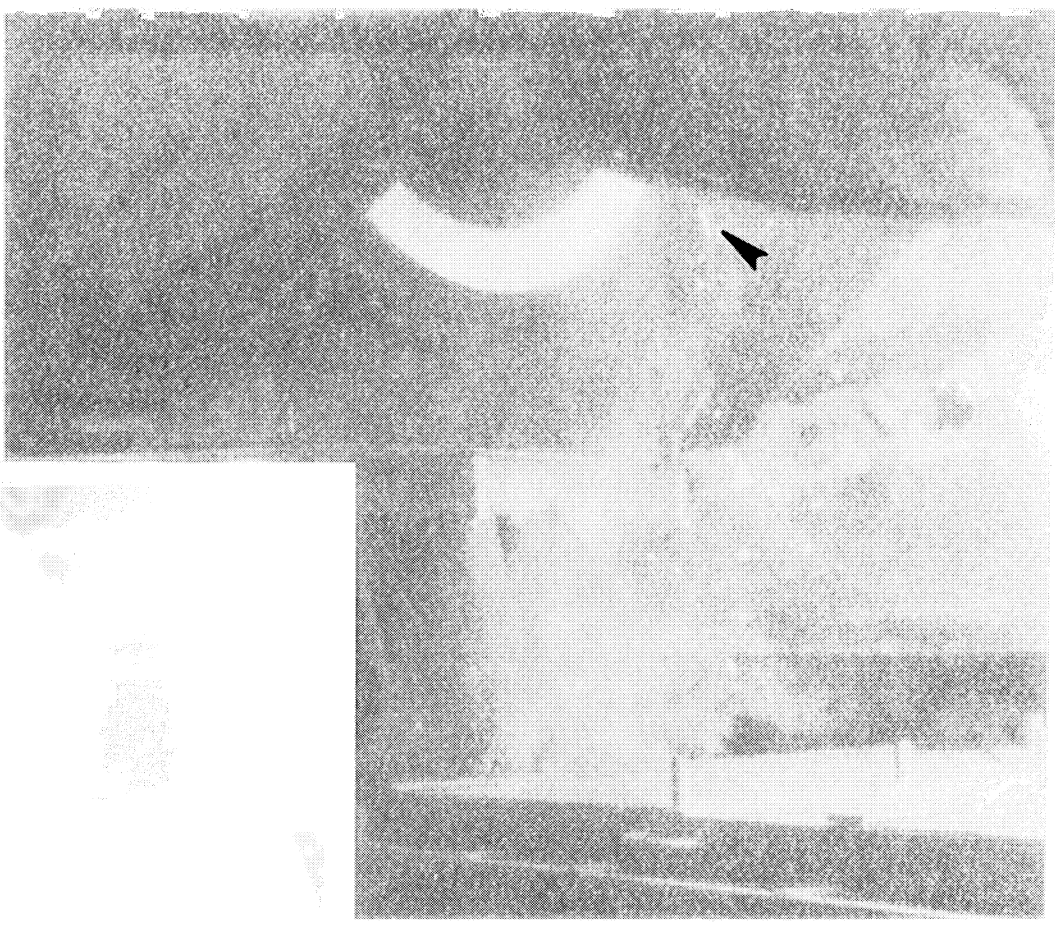
Photo 8: GSE Tile Shim

An orange-colored GSE tile shim/spacer falling outboard of SSME #3 appeared to originate from the base heat shield. Another orange-colored tile shim/spacer first appeared behind the LH OMS nozzle heat shield and fell aft past SSME #1 without contacting flight hardware.

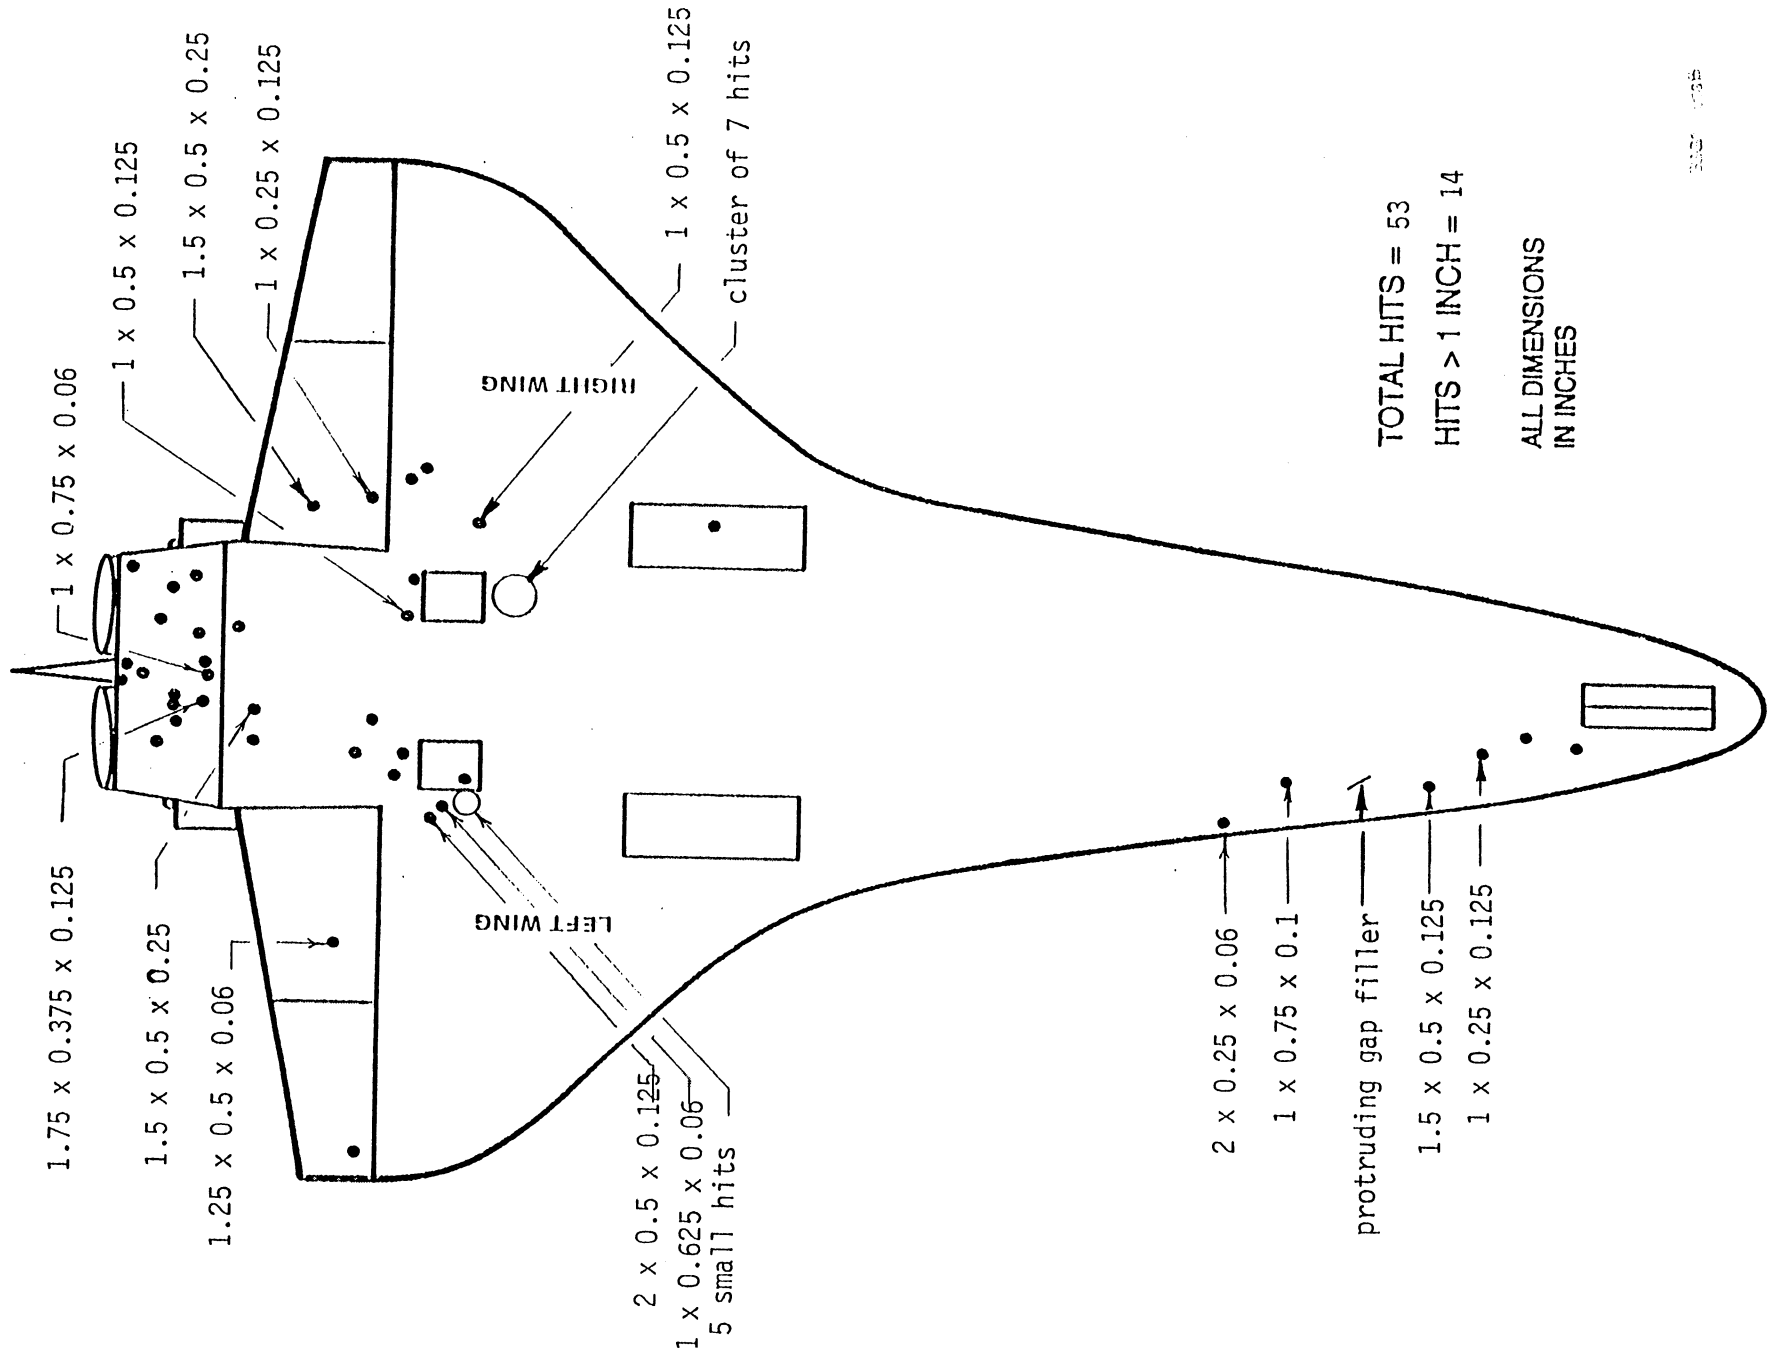
Figure 1: Orbiter Lower Surface Debris Damage Map

The Orbiter lower surface tiles sustained 53 damage sites, of which 14 were larger than 1-inch long in size. The largest lower surface tile damage site was located on the left chine about midway between the nose gear door and the left main gear door. The site measured 2-inches long by 1/4-inch wide by 1/16-inch maximum depth.

Tile damage sites aft of the LH2 and LO2 ET/ORB umbilicals were typical. The damage was most likely caused by impacts from umbilical ice or shredded pieces of umbilical purge barrier material flapping in the air stream, both of which were observed in launch films.

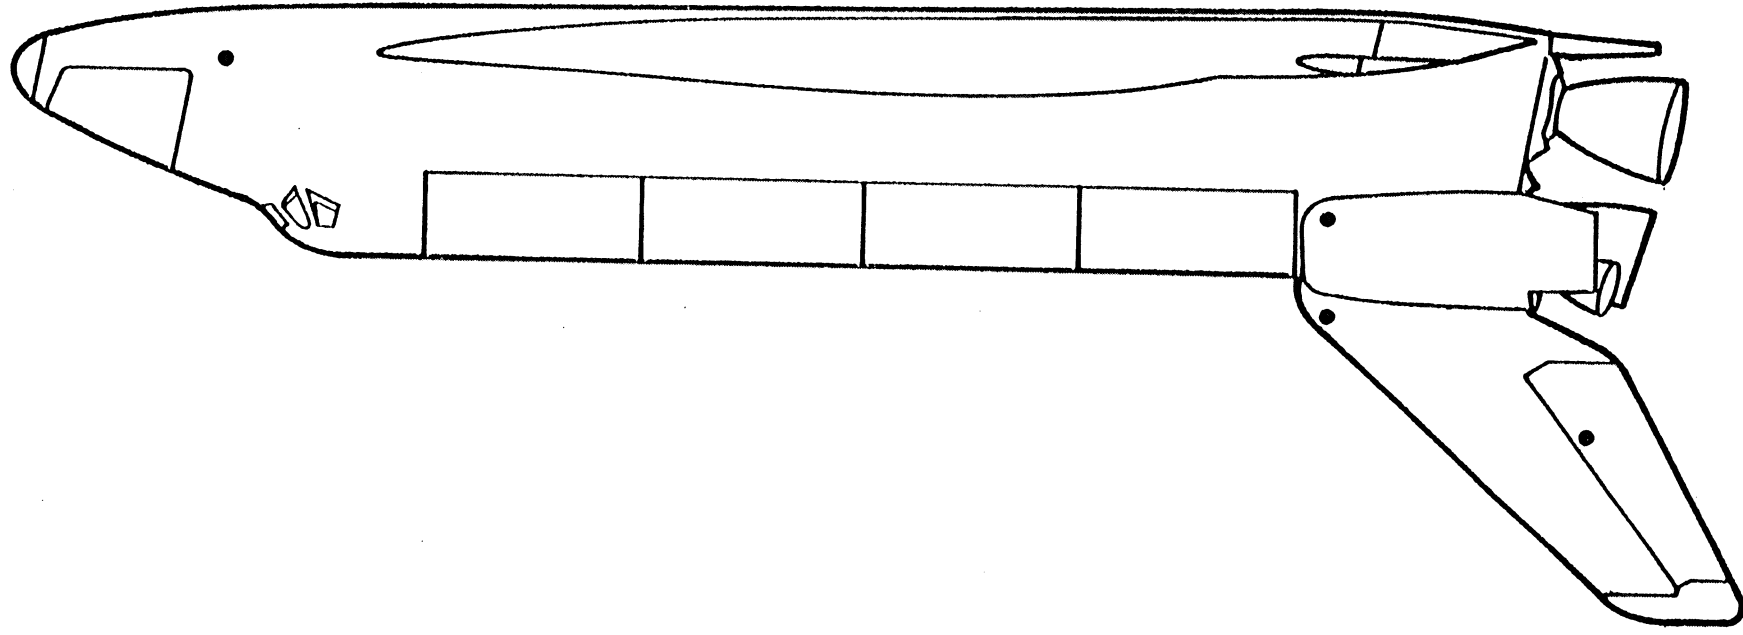
Figure 2: Orbiter Right Side Debris Damage Map

TOTAL HITS = 4
HITS > 1 INCH = 0

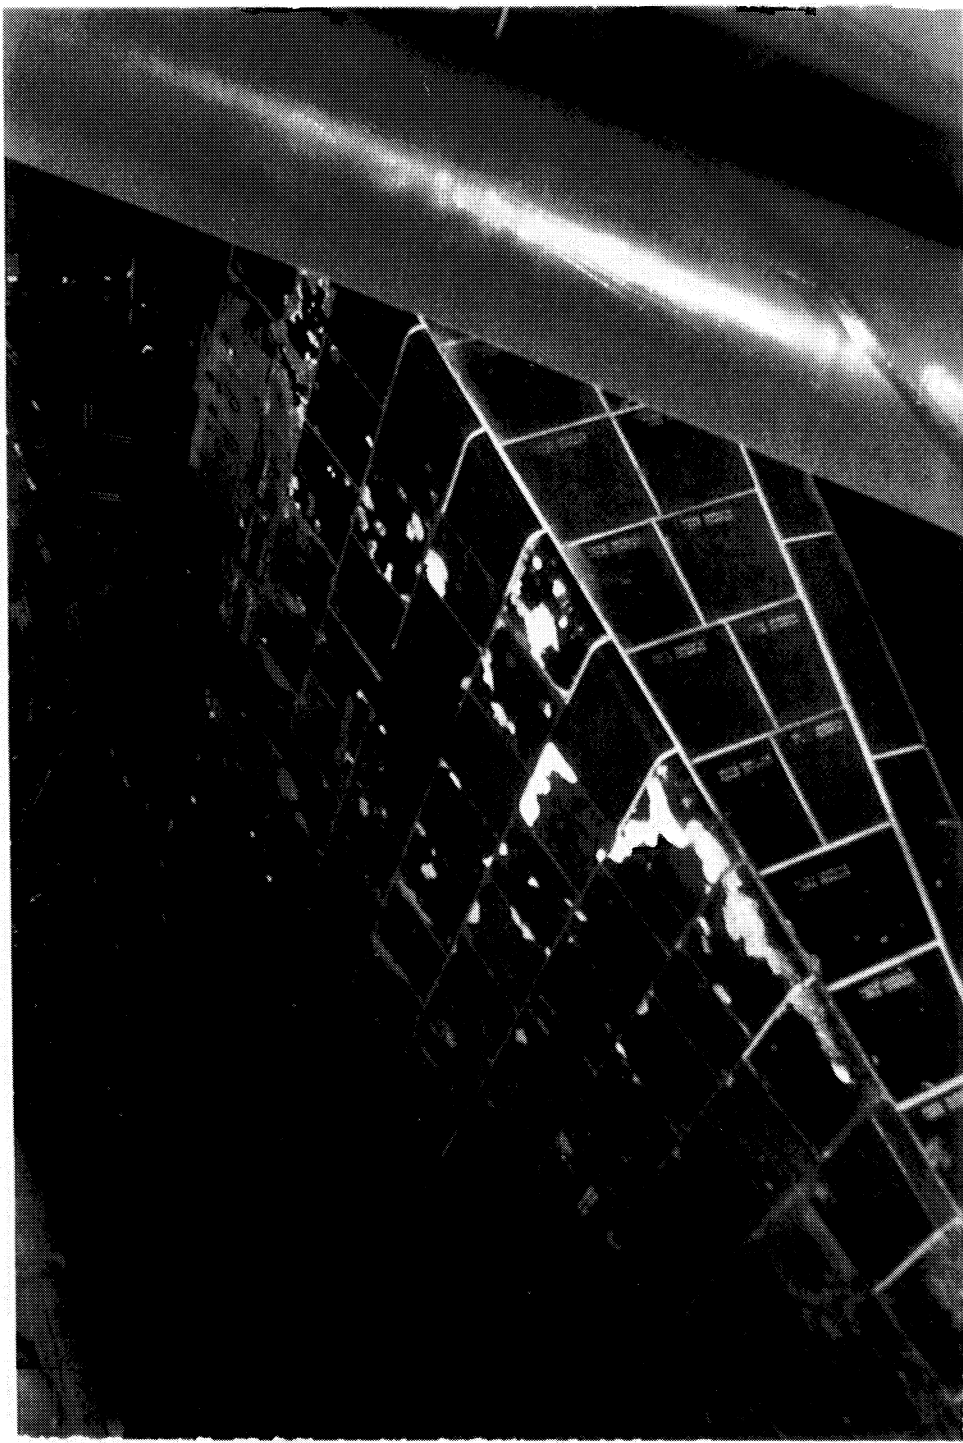
Photo 19: Body Flap Upper Surface Tile Damage

Tiles on the upper surface of the body flap near the outboard edges sustained greater than usual damage from downward firing RCS thrusters.

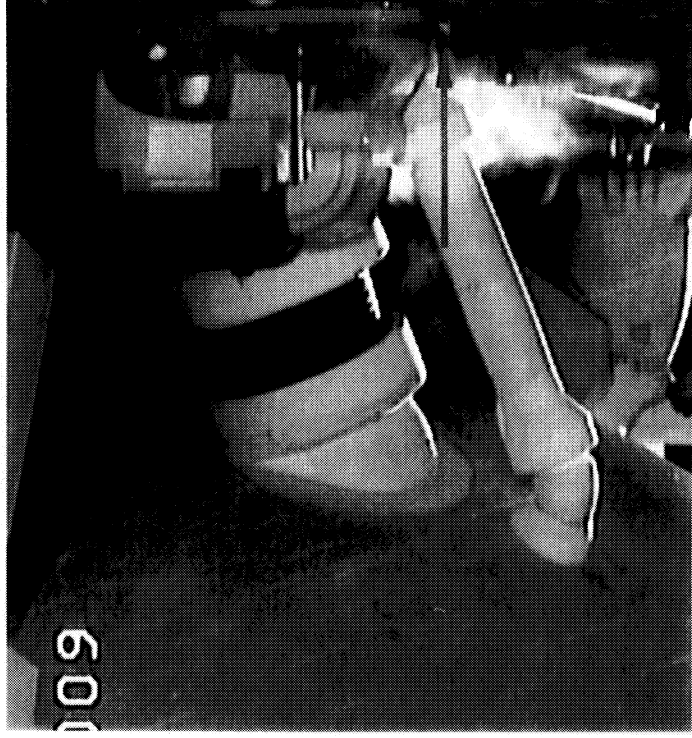
Figure 2.1 (A) Ice Debris Strike to Umbilical Well Door Sill

Multiple pieces of ice debris were seen falling from the LH2 ET/Orbiter umbilical during SSME ignition. Ice debris was seen to strike the LH2 umbilical well door sill (08:55:11.86 UTC) and the LH2 four inch recirculation line (08:55:15.20 UTC). No damage was noted (Camera OTV009).

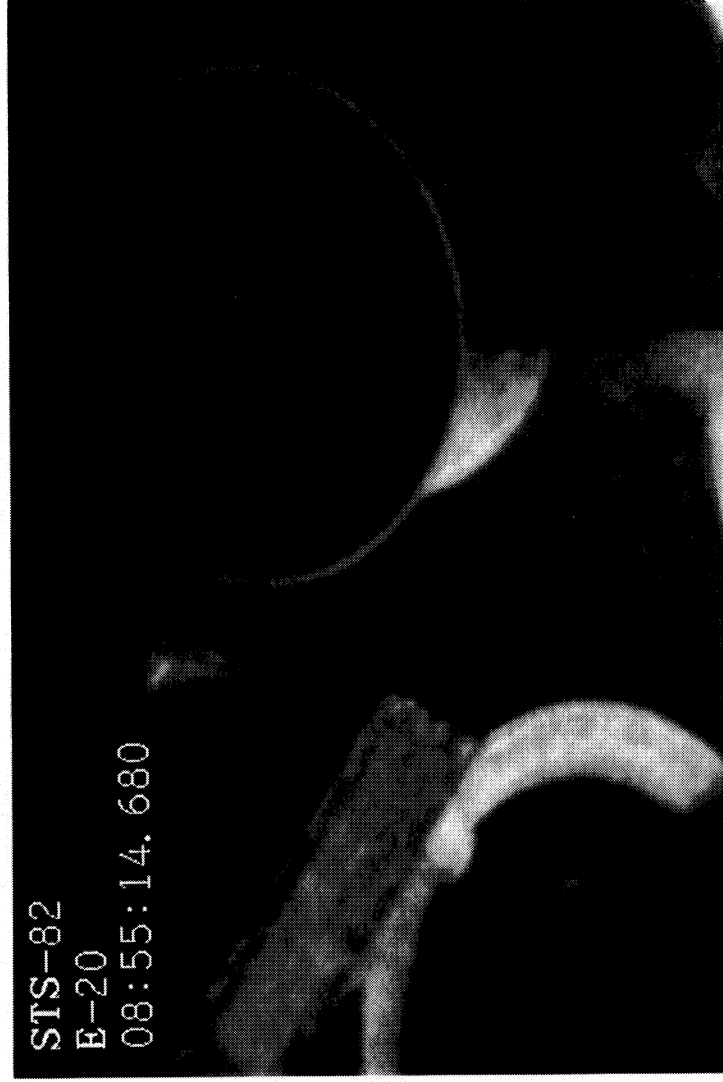
Figure 2.1 (B) Possible Tile Shim Debris Near Left RCS Stinger

A single, red-colored, rectangular-shaped piece of debris (possibly a tile shim) was seen coming from behind the left RCS stinger and fell aft between SSME #1 and SSME #2 during SSME ignition (08:55:14.680 UTC). No follow-up action was requested (Camera E20).

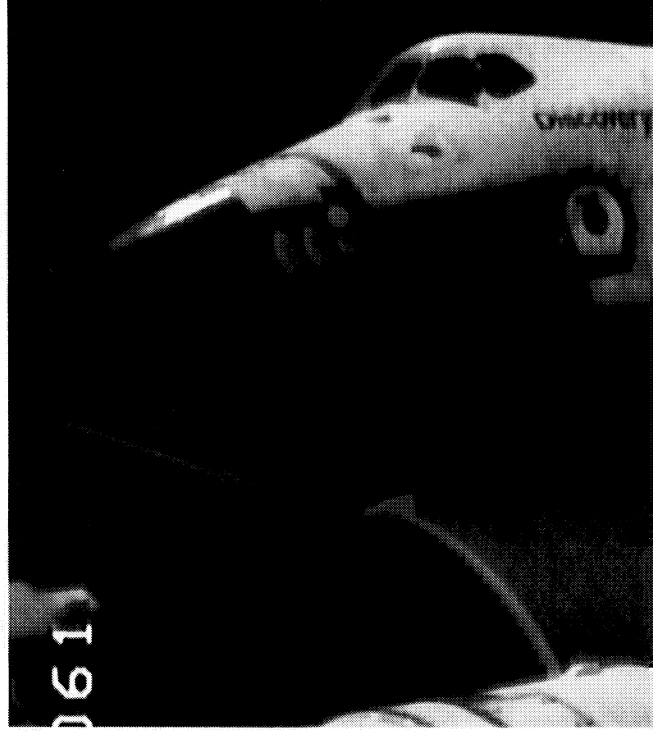
Figure 2.1 (C) White Debris Near ET Upper Feedline Bellows

Four pieces of white debris, first seen near the ET upper feedline bellows, fell aft between the Orbiter and the ET just prior to liftoff (08:55:14.0 UTC). A fifth

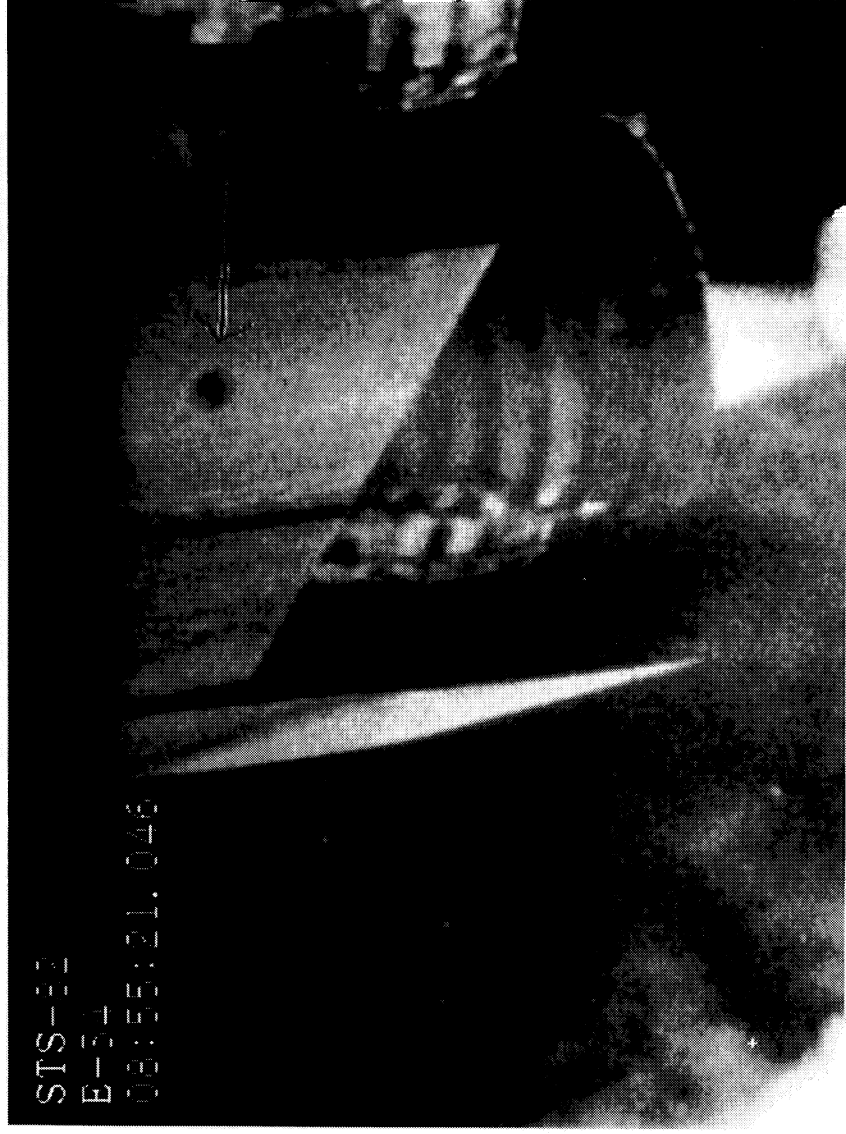
Figure 2.1 (D) Unidentified Piece of Debris Near Left Elevon

A dark unidentified piece of debris (possibly a bird) was seen falling aft near the left elevon during liftoff (08:55:21.046 UTC) (Camera E34).

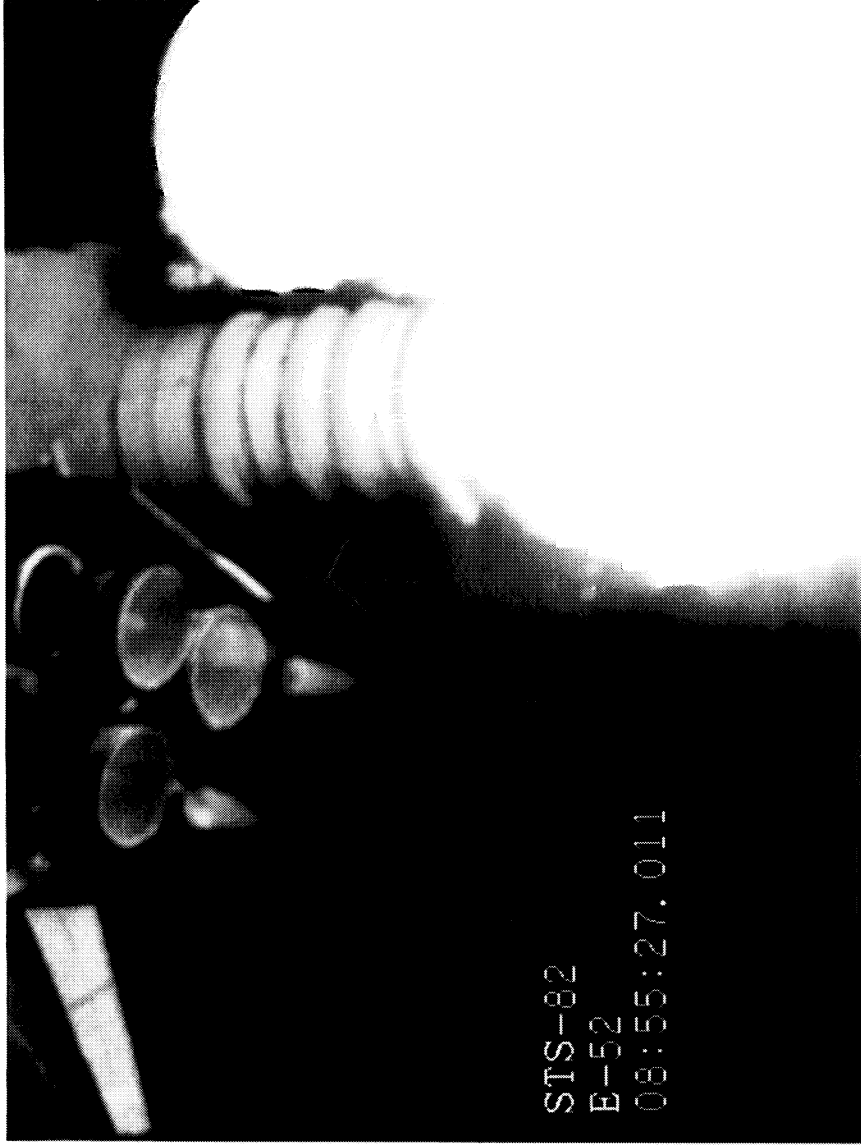
Figure 2.2 (A) Debris at Beginning of Roll Maneuver.

Debris (probably ET/Orbiter purge barrier material) fell aft of the launch vehicle at the beginning of the roll maneuver (08:55:27.0 UTC). A long piece of tape-like material (probably from the ET/Orbiter umbilical area) was also seen falling aft along the body flap (08:55:27.6 UTC) (Cameras E52, E54, E212, E222, E223).

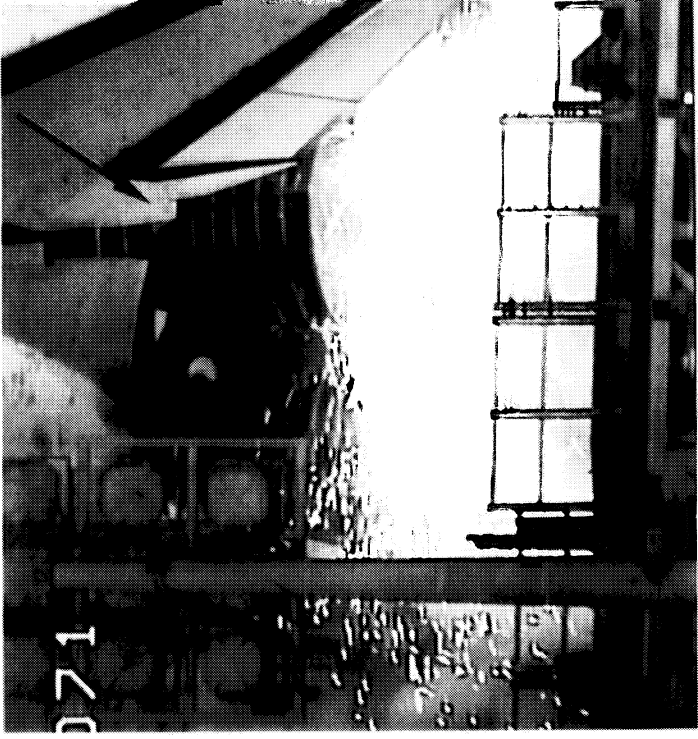
Figure 2.3 Orange Vapor during SSME Ignition

Orange vapor, probably free burning hydrogen, was seen above the SSME rims, near the body flap, and near the base of the vertical stabilizer during SSME ignition (08:55:14 UTC). Orange vapors have been seen on previous missions (Cameras OTV071, E4, E19).

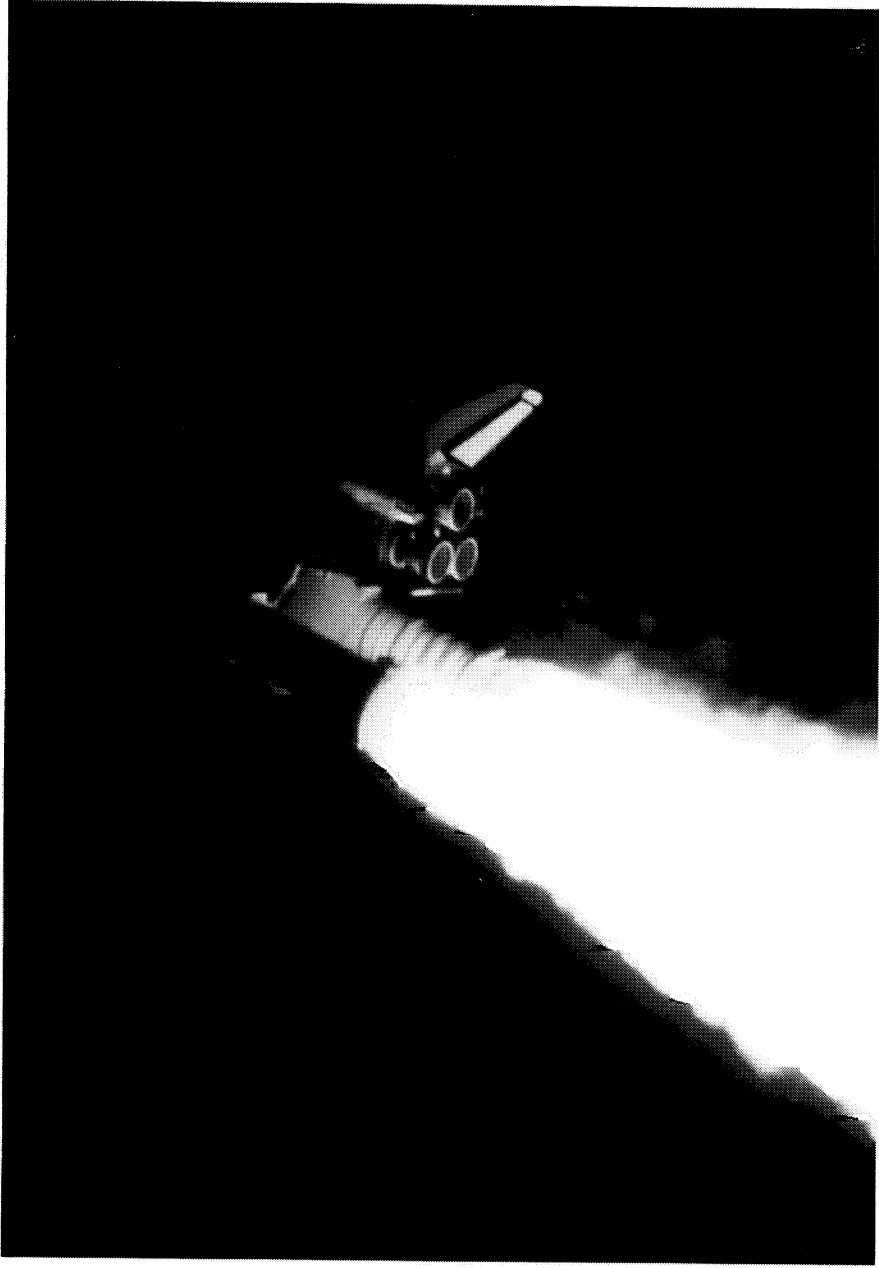
Figure 2.4 (A) Flare in SSME Exhaust Plume

Seven orange-colored flares (probably RCS paper debris induced) were seen in the SSME exhaust plume during ascent (Cameras E220, E212, E222, E223). The orange-colored flares were seen over a five second time period beginning at 08:55:50.695 UTC (33.671 seconds MET). Flares in the SSME exhaust plumes have been seen on previous missions. However, the rapid succession of the STS-82 flares and the resultant color changes seen in the SSME exhaust plumes were more obvious than typically seen on previous missions. Camera film (E220) of the flares was reviewed with an engineer from the JSC Structures and Mechanics Division/ES3. The ES3 engineer concluded that the flares were not caused by falling tiles. No follow-up action was requested. A description of the flare events is shown in Table 2.4.
